PROPERTY INSPECTION REPORT

**1530 W 261 Street
Sheridan IN 46069**

Wednesday, 2/28/2024

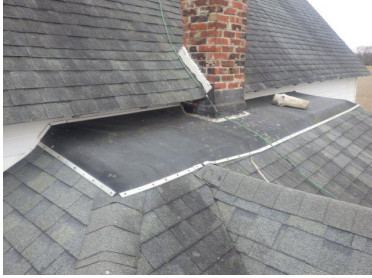
1 EPDM Rubber

Rubber Roof Has Separated And Pulled Loose In Several Locations

Repair/ Replace Rubber Roof To Prevent Additional Leaks

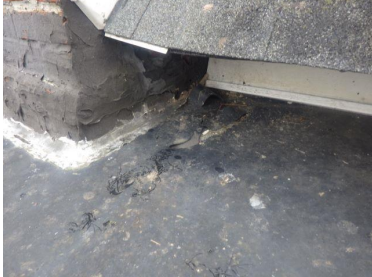
2 EPDM Rubber

Additional Photo Of:
Rubber Roof Has Separated And Pulled Loose In Several Locations

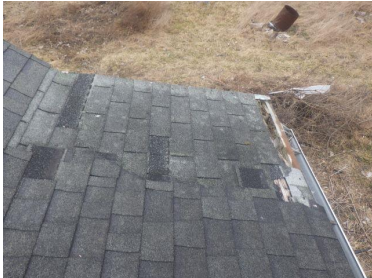
3 Fiberglass Shingles

Missing Shingles Tabs Were Noted Throughout Roof

Repairs Needed To Prevent Additional Water Intrusion

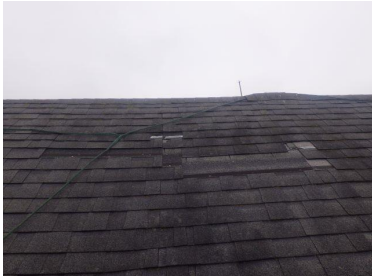
4 Fiberglass Shingles

Additional Photo Of:
Missing Shingles Tabs Were Noted Throughout Roof

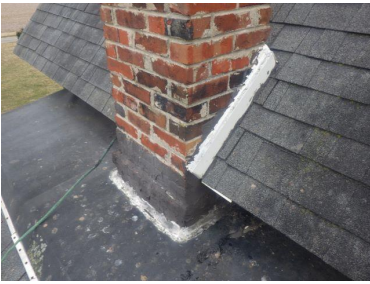
6

Chimney Flashing	
		<i>Flashing Is Missing And Or Marginally Installed At Chimney And Is Currently Leaking</i>	<i>Qualified Contractor Should Be Consulted For Proper Repairs To Prevent Water Intrusion</i>

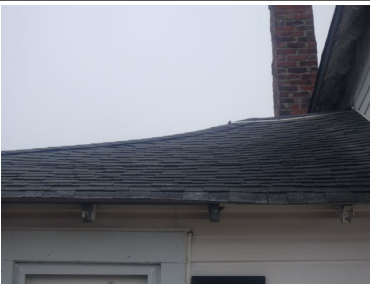
8

Roof Framing	
		<i>Sagging Roof Framing Noted At Utility Room</i>	<i>Further Evaluation By Qualified Contractor And Repaired As The Contractor Determines Is Necessary</i>

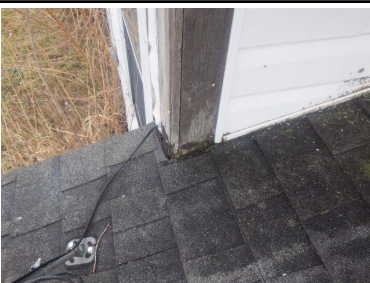
9

Joining Wall Flashing	
		<i>Joining Wall Flashing Missing In Several Locations</i>	<i>Qualified Contractor Should Be Consulted For Proper Repairs</i>

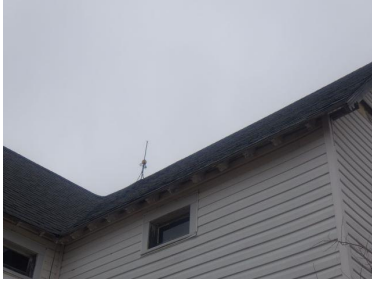
10

Gutters Were Missing At Time Of Inspection

Install Gutters To Properly Divert Water Away From Foundation

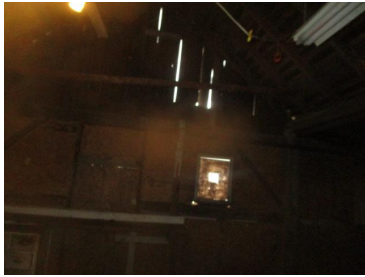
1

Additional Photo Of:
Rot, Termite And Powder Post Beetle Damage Noted Throughout Framing At Garage. Note Garage Has Shifted And Is Sloping Off Foundation Due To Damaged

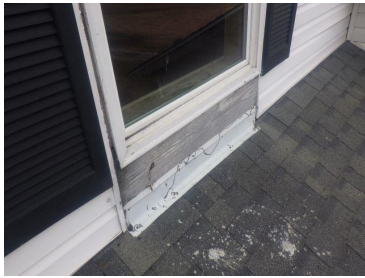
2

Damaged And Or Missing Trim And Siding Noted Throughout Exterior Of Home

Repairs Needed To Prevent Water Intrusion

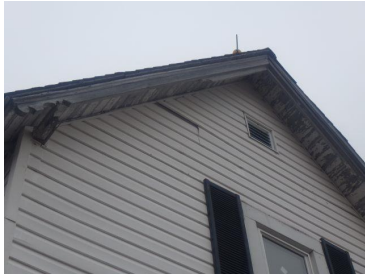
3

Additional Photo Of:
Damaged And Or Missing Trim And Siding Noted Throughout Exterior Of Home

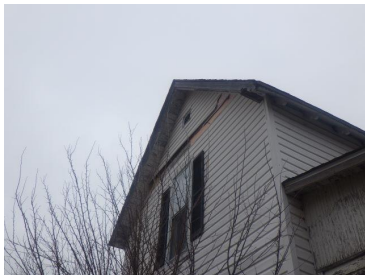
4

Additional Photo Of:
Damaged And Or Missing Trim And Siding Noted Throughout Exterior Of Home

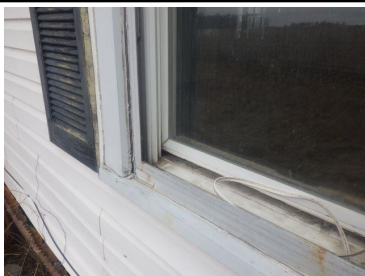
5

Several Broken And Or Damaged Window Sash's Were Noted At Time Of Inspection . No Window Sash's Will Not Closet And Seal

Repair/ Replace Windows

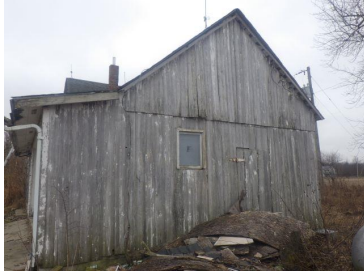
6

Rot, Termite And Powder Post Beetle Damage Noted Throughout Framing At Garage. Note Garage Has Shifted And Is Sloping Off Foundation Due To Damaged

Further Evaluation By Qualified Contractor And Repaired As The Contractor Determines Is Necessary

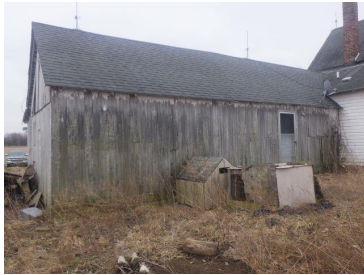
7

Additional Photo Of:
Rot, Termite And Powder Post Beetle Damage Noted Throughout Framing At Garage. Note Garage Has Shifted And Is Sloping Off Foundation Due To Damaged

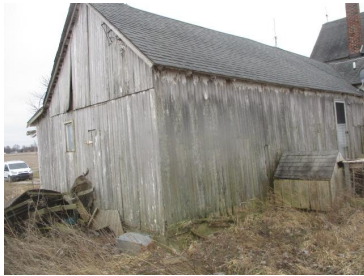
8

Additional Photo Of:
Rot, Termite And Powder Post Beetle Damage Noted Throughout Framing At Garage. Note Garage Has Shifted And Is Sloping Off Foundation Due To Damaged

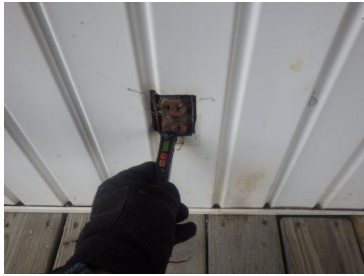
9

Missing / Damaged Weather Cover Noted At Electrical Outlet At Front Porch

Repair / Replace Weather Cover

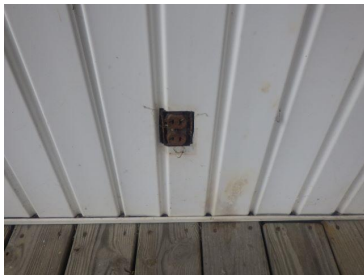
10

Missing G F I Protection Noted At Front Porch

Install G F I Outlets Where Required

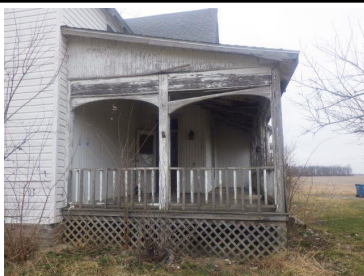
11

Rot And Inadequate Support Noted Throughout Framing At Front Porch And Roof Structure At Front Porch

Further Evaluation By Qualified Contractor And Repaired As The Contractor Determines Is Necessary

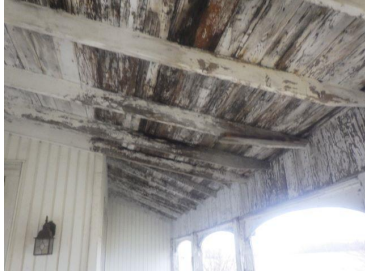
12

Additional Photo Of:
Rot And Inadequate Support Noted Throughout Framing At Front Porch And Roof Structure At Front Porch

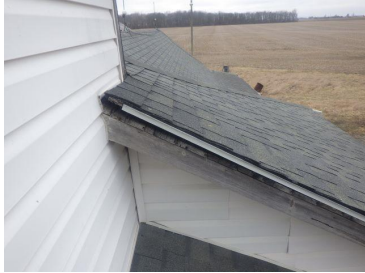
13

Rot Noted Throughout Fascia And Exposed Sheathing
Qualified Contractor Should Be Consulted For Proper Repairs/ Replacement

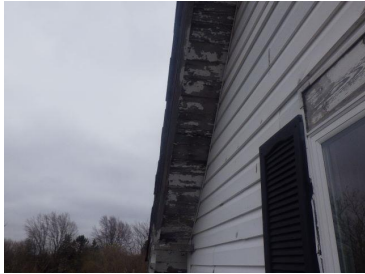
14

Additional Photo Of:
Rot Noted Throughout Fascia And Exposed Sheathing

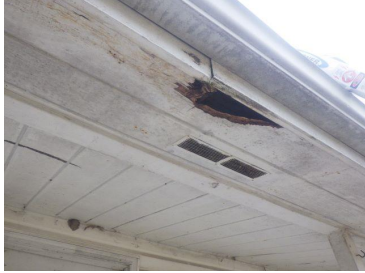
15

Rot Noted Throughout Exterior Wood Trim
Repair/ Replace Damaged Wood Trim To Prevent Water Intrusion

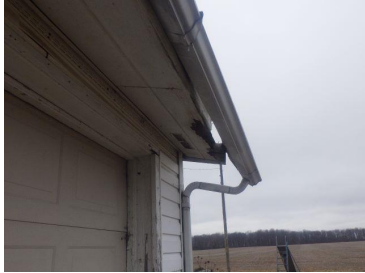
16

Additional Photo Of:
Rot Noted Throughout Exterior Wood Trim

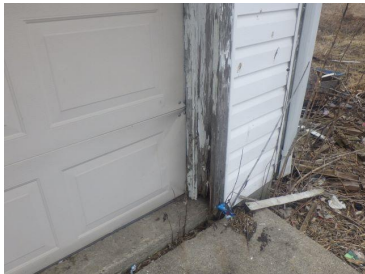
17

Additional Photo Of:
Rot Noted Throughout Exterior Wood Trim

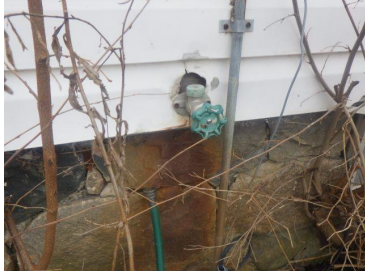
18

Freeze Damage Noted To Exterior Hose Bib

Replace Damaged Hose Bib And Water Line By A Qualified Contractor

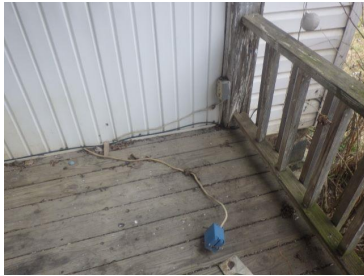
1

Exposed And Substandard Wire Noted At Front Porch

Qualified Contractor Should Be Consulted For Proper Repairs

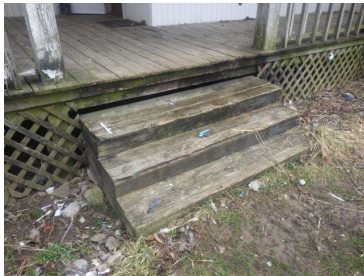
2

Rot Noted At Front Porch Steps And Stringers

Replace Damaged Steps

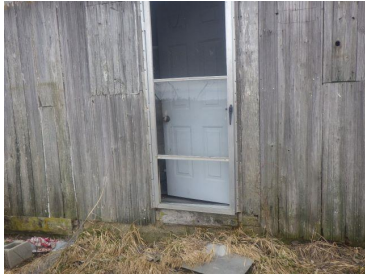
1 Service Door

Deterioration Noted At Garage Service Door

Replace Service Door

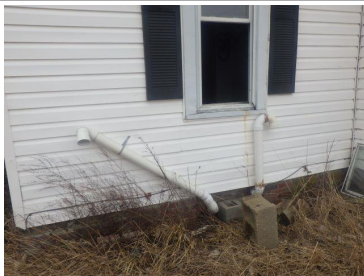
1

Improper Venting Of Furnace Flue Pipe

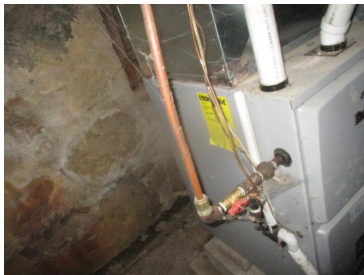
2

Gas Was Empty At Time Of Inspection And Furnace Could Not Be Inspected

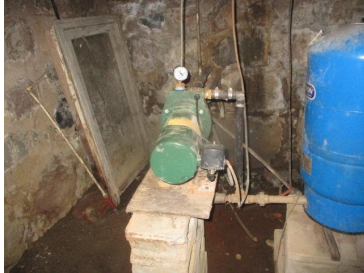
1 Water Supply

Water Supply Lines After Well Pump Have Frozen And Split In Several Locations Throughout Interior, Basement And Crawl Space. Note Water Was Off And Could Not Be Inspected At Time Of Inspection

Qualified Contractor Should Be Consulted For Proper Repairs

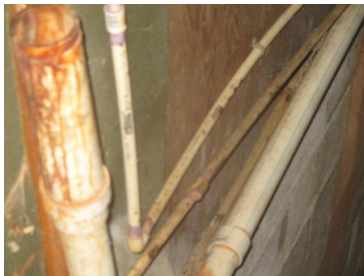
2 Water Supply

Additional Photo Of:
Water Supply Lines After Well Pump Have Frozen And Split In Several Locations Throughout Interior, Basement And Crawl Space. Note Water Was Off And Could Not Be Inspected At Time Of Inspection

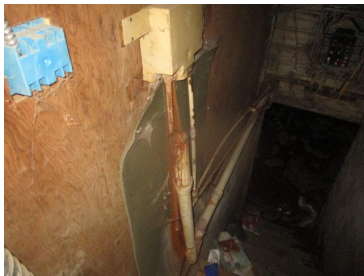
3 Water Supply

Additional Photo Of:
Water Supply Lines After Well Pump Have Frozen And Split In Several Locations Throughout Interior, Basement And Crawl Space. Note Water Was Off And Could Not Be Inspected At Time Of Inspection

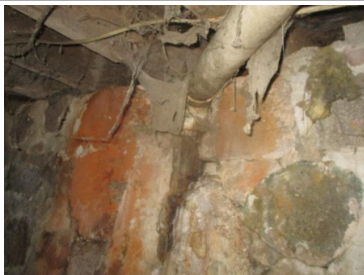
4 Cast Iron Waste Pipes

Deteriorated Cast Iron Waste Piping

Replace Damaged Cast Iron Waste Pipes By A Qualified Plumber To Prevent Leakage

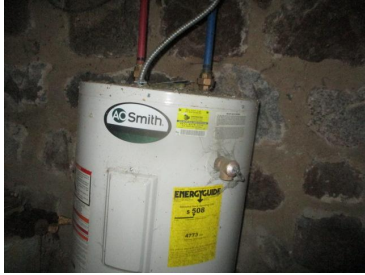
6

<p>Water Heater</p> <p><i>Missing Extension Pipe At Water Heater Relief Valve</i></p>	<p><i>Install Extension Pipe At Relief Valve To Perform Its Intended Function Properly</i></p>
----------	---	--	--

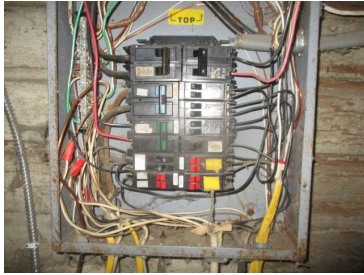
1

Main Panel Needs To Be Properly Bonded

Qualified Contractor Should Be Consulted For Proper Repairs

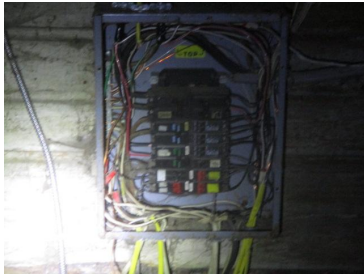
2

Panel Cover Was Missing At Time Of Inspection

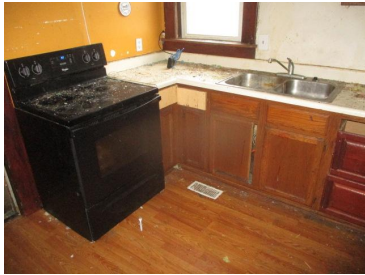
1

Damaged Appliances And Cabinets Noted Throughout Kitchen

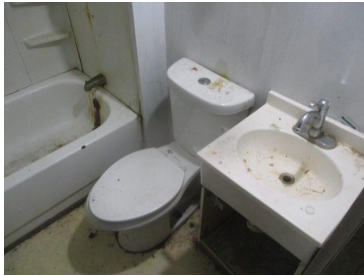
1

Freeze Damage Noted Throughout Water And Drain Lines In Bathrooms. Note Water Was Off And Plumbing Could Not Be Inspected

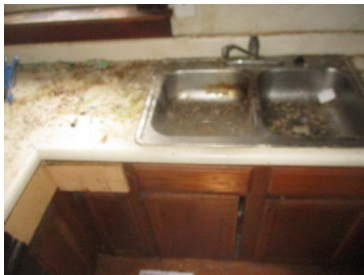
1

Mice Feces Noted Throughout Interior Of Home From A Active Infestation

Qualified Contractor Should Be Consulted For Proper Repairs

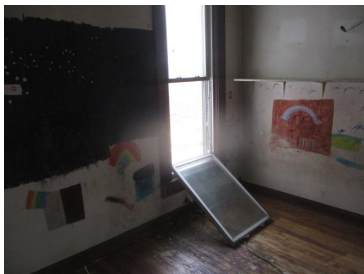
2

Broken Sash Clips Noted Throughout Window At Time Of Inspection. Note Windows Will Not Close Due To Damaged Sash Clips

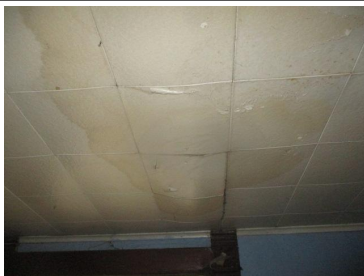
3

Suspected Asbestos Material At Ceiling Tiles Throughout Interior Of Home

Further Evaluation By Qualified Contractor And Repaired As The Contractor Determines Is Necessary For Safety Reasons

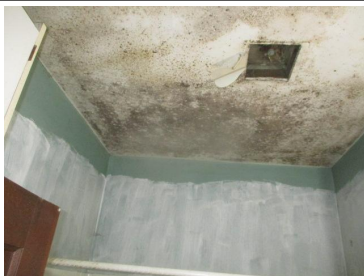
4

Mold Like Substance Noted Throughout Interior Walls And Ceilings

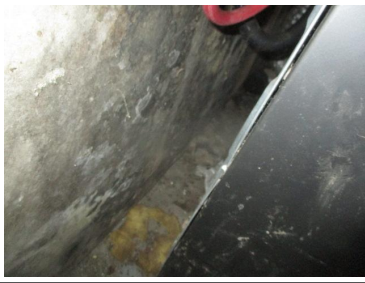
5

Walls & Ceiling <i>Additional Photo Of: Mold Like Substance Noted Throughout Interior Walls And Ceilings</i>	
----------	---	--	--

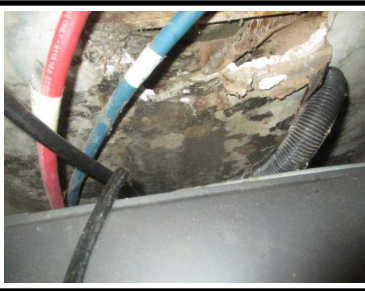
6

Walls & Ceiling <i>Additional Photo Of: Mold Like Substance Noted Throughout Interior Walls And Ceilings</i>	
----------	---	--	--

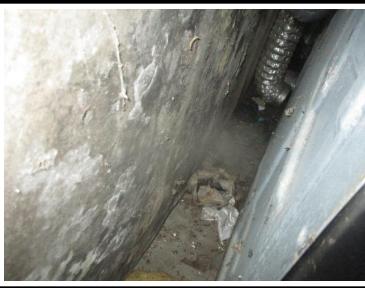
7

Walls & Ceiling <i>Additional Photo Of: Mold Like Substance Noted Throughout Interior Walls And Ceilings</i>	
----------	--	--	--

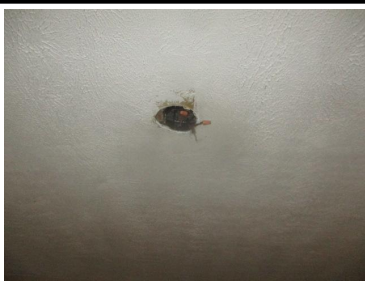
8

Lights & Outlets <i>Open Junction Box's Were Noted Throughout Interior</i>	<i>Qualified Contractor Should Be Consulted For Proper Repairs</i>
----------	---	--	--

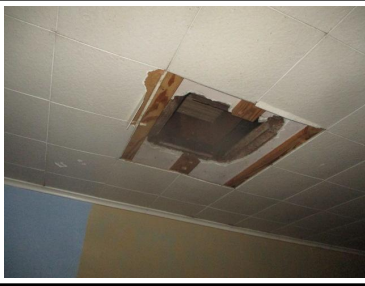
9

Walls & Ceiling <i>Damaged Noted Throughout Interior Walls And Ceiling</i>	<i>Qualified Contractor Should Be Consulted For Proper Repairs</i>
----------	---	--	--

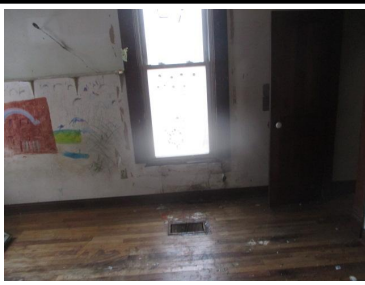
10

Walls & Ceiling <i>Additional Photo Of: Suspected Asbestos Material At Ceiling Tiles Throughout Interior Of Home</i>	
-----------	---	--	--

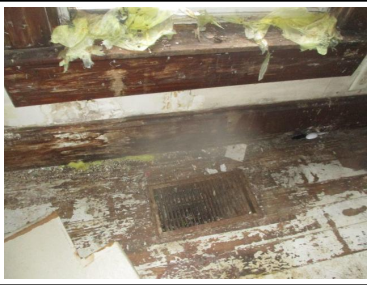
11

<p>Walls & Ceiling</p> <p><i>Additional Photo Of: Damaged Noted Throughout Interior Walls And Ceiling</i></p>
----	---	---

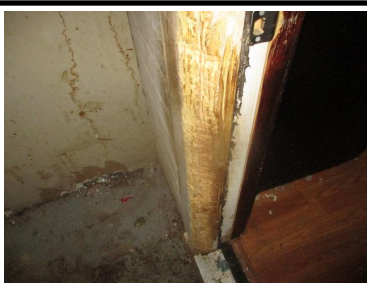
12

<p>Doors</p> <p><i>Animal Damage Noted Throughout Interior And Exterior Doors</i></p> <p><i>Repair/ Replace Doors</i></p>
----	---	--

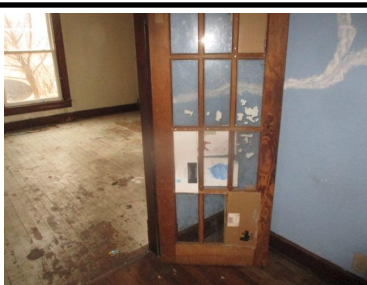
13

<p>Doors</p> <p><i>Additional Photo Of: Animal Damage Noted Throughout Interior And Exterior Doors</i></p>
----	--	--

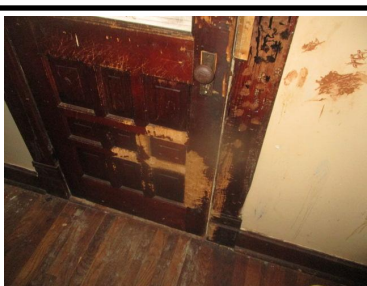
14

<p>Doors</p> <p><i>Additional Photo Of: Animal Damage Noted Throughout Interior And Exterior Doors</i></p>
----	---	--

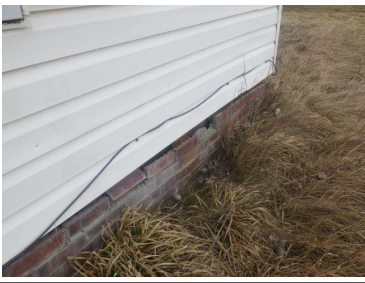
5

<p>Foundation Walls</p> <p><i>Additional Photo Of: Cracking, Deterioration And Outward Deflection Noted Throughout Foundation Of Home</i></p>
6

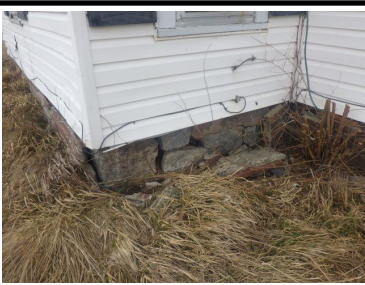
<p>Foundation Walls</p> <p><i>Additional Photo Of: Cracking, Deterioration And Outward Deflection Noted Throughout Foundation Of Home</i></p>
7

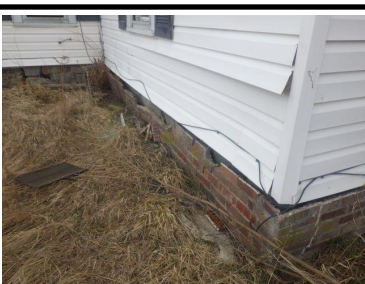
<p>Foundation Walls</p> <p><i>Additional Photo Of: Cracking, Deterioration And Outward Deflection Noted Throughout Foundation Of Home</i></p>
8

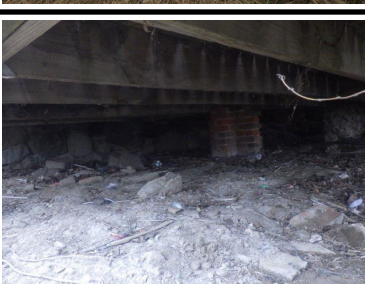
<p>Foundation Walls</p> <p><i>Additional Photo Of: Cracking, Deterioration And Outward Deflection Noted Throughout Foundation Of Home</i></p>
9

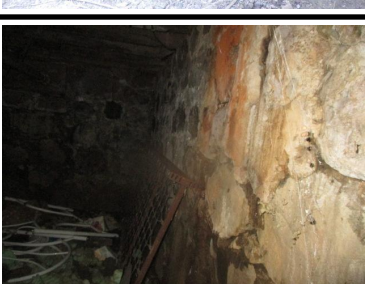
<p>Foundation Walls</p> <p><i>Additional Photo Of: Cracking, Deterioration And Outward Deflection Noted Throughout Foundation Of Home</i></p>
10

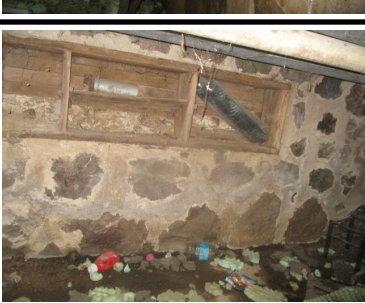
<p>Foundation Walls</p> <p><i>Additional Photo Of: Cracking, Deterioration And Outward Deflection Noted Throughout Foundation Of Home</i></p>

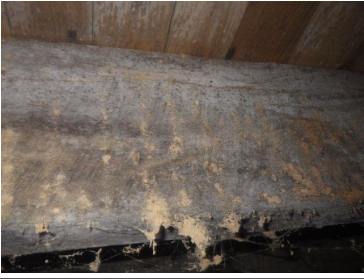
11

Floor Framing	
		Termite And Powder Post Beetle Damage Noted Throughout Framing In Cellar And Crawl Space.	Further Evaluation By Qualified Contractor And Repaired As The Contractor Determines Is Necessary

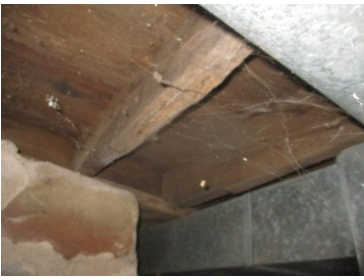
12

Floor Framing	
		Additional Photo Of: Termite And Powder Post Beetle Damage Noted Throughout Framing In Cellar And Crawl Space.

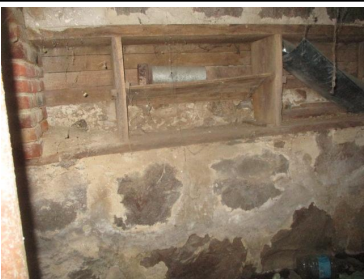
13

Floor Framing	
		Additional Photo Of: Termite And Powder Post Beetle Damage Noted Throughout Framing In Cellar And Crawl Space.

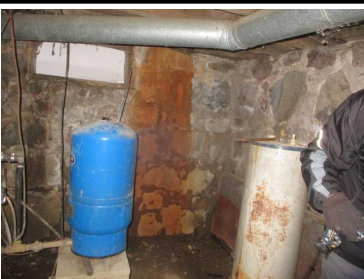
14

Dryness	
		Excessive Moisture / Humidity Noted Throughout Crawl Space And Basement	Further Evaluation By Qualified Contractor And Repaired As The Contractor Determines Is Necessary
